UNIT Tree Inspections

UNIT GUIDE 2023-24

Assignment Brief LO 1 and LO2

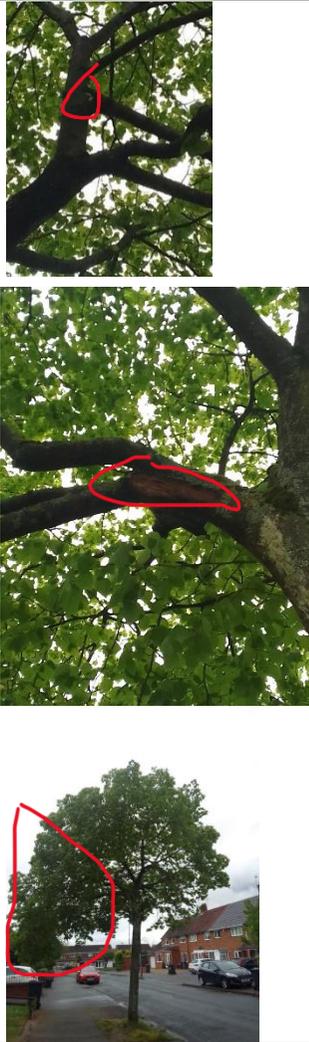
Ref	Species	Description	Measurements	Survey Notes	Risk Rating	Condition	Inspect Period
T01	Lime, small-leaved (Tilia cordata)	Owned by BCC Target # - footpath; pedestrian way -within the drip line - Occupancy: Frequent (3) tenants but also pedestrians going to the small shops nearby - Not practical to move the target.	Height (m): 8 Crown Radius (m): 6.50 North: 3 East: 3.50 West: 2.50 South 2 DBH (cm): 75 Life Stage: Mature Life Exp.: 200+ Years As a street tree perhaps 50+	Wind Exposure: full mostly from North Crown Size: Medium Unbalanced crown. One broken branch hanging on and could fall on target (human, car) Lichen on bark One branch broke The tree tries to balance the weight Ground cement stone non- permeable One branch on the west side bows down with leaves to a height of 1.60 metres from the ground, people taller must walk around the branch. The branch on the south side missing; broke up. The waste truck came by and hit the hanging branches on the east side which could have happened before and that could be the reason why this branch is broken.	Moderate, except one splitter branch about to fall on a target tension on the opposite branch through the split branch	Fair	Immediately

Ref	Species	Recommendation	Work Timescale	Photo
T01	Lime, small-leaved (<i>Tilia cordata</i>)	<p>Structural pruning of entire tree and target pruning of split and cracked branches</p> <p>Ground maintenance for roots to breathe, taking water and nutrients in</p> <p>branch on the west side overhanging through weight balancing. Tension on this branch. Needs Inspection regularly, especially from May to Autumn as leaves add weight to the branch, I measured today the leaves came down to 1.6 metres in height from the ground.</p>	<p>14-May-2024 (immediately for the broken hanging branch which could hit the target human/car)</p> <p>Ground maintenance within 6 months</p>

Tree 01 would benefit from target pruning the branches which are already split and cracked. Target pruning, or selective branch removal, aims to improve tree health, safety, and aesthetics by removing specific problematic or unwanted branches, potentially impacting the tree's growth and structure. Target pruning, when done properly, promotes effective wound healing from the cut. The tree will be more susceptible to decay and parasites if the cut is too close to the trunk, and it cannot heal if it is too short. The branch on the left side of the tree must be structurally pruned as the branch is hanging down with a lot of weight which makes the branch susceptible to breakage. The tree will be less vulnerable to harm from wind, snow, and other stressors because of its stronger, more balanced structure.

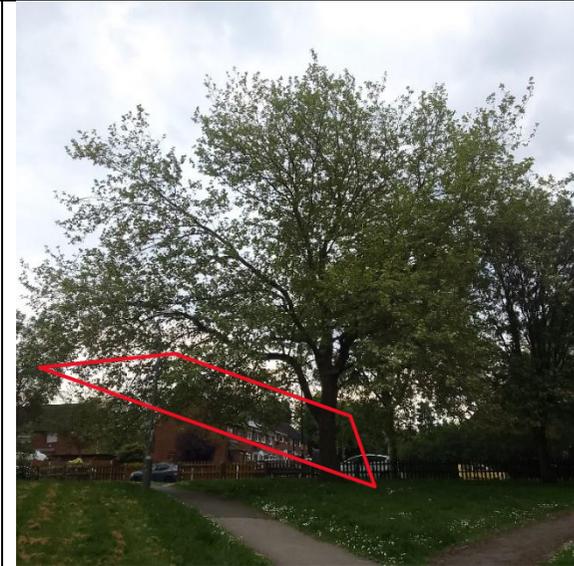
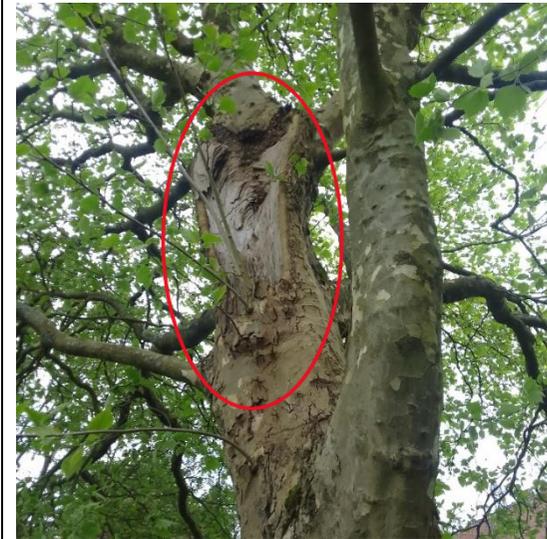
Ref	Species	Description	Measurements	Survey Notes	Risk Rating	Condition	Inspect Period
T02	London Plane (Platanus hybrida)	Owned by the GSA Association Target # - footpath; pedestrian way -within the drip line - Occupancy: Frequent (3) tenants but also Woodgate Valley users - Not practical to move the target.	Height (m): 25 Crown Radius (m): 10 North: 7 East: 10 West: 8 South 6 DBH (cm): 180 Life Stage: Mature Life Exp.: 40+ Years	Wind Exposure: mostly from North Crown Size: Large. Unbalanced crown. struck by lightning last year Branch East bowing down Leaves from May on bowing down until Autumn to under 1.5 height from the ground Tension on the branch because of leaves Bark disease: <u>Massaria</u> (<u>Splanchnonema platani</u>)	Moderate to High because of eventual Storm; tension in branch	Good Update 14/5/24 poor condition	6 months

T02	London Plane (<i>Platanus hybrida</i>)	Large branch overhanging through lightning. Needs Inspection regularly, especially during May to	12-May-2024 (6 months)

Autumn as leaves add weight to the branch, I measured last year's leaves came down to under 1.5 meters from the ground.

The large branch on the left side of the picture, marked red, poses a risk for pedestrians as the weight of the branch came down to a height of 1.50 meters above the ground.

Pruning of branches is recommended.

For **Tree 02** Install cables or braces to provide additional support to the branch and prevent it from breaking. These systems can help reduce stress on the branch by redistributing the weight more evenly.

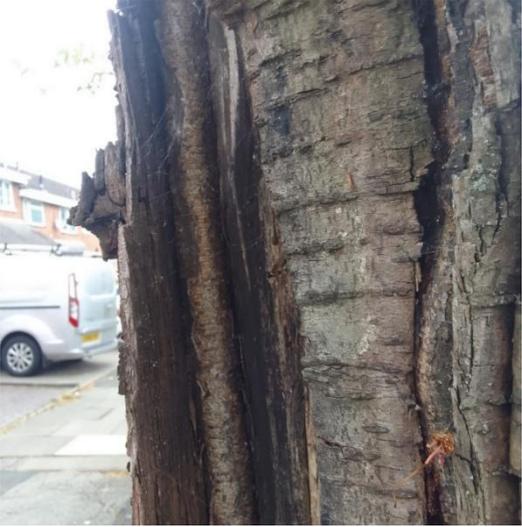
Ref	Species	Description	Measurements	Survey Notes	Risk Rating	Condition	Inspect Period
T03	Wild Cherry (Prunus avium)	Owned by BCC Target # - footpath; pedestrian way Single car park - Occupancy: Frequent (3) tenants, pedestrians - Not practical to move the target.	Height (m): 7-8 Crown Radius (m): 8 North: 2.20 East: 1 West: 1.70 South 3 DBH (cm): 75 Life Stage: Mature Life Exp.: 3+ Years under this condition Life Exp.: 60+ years	Wind Exposure: mostly from North Crown Size: Small Unbalanced crown. North branches touch above and between the utility line East branches almost straight up within 1 m Shear bark split Black Fungus The trunk is square, not the round you would expect from a tree Structural damage Dead branches in-between The first stem occurs at a height of 1.86 metre Dieback between 1-10%	Moderate	Poor	1 year

<p>T03</p>	<p>Wild Cherry (Prunus avium)</p>	<p>The decay of the tree must be watched.</p> <p>First Aid: Pruning of the straight branches east side that go and touch already the utility cables within 3 months</p> <p>Removal of the tree would be recommended and planting a new street tree Shear bark split Black Fungus The trunk is square, not the round you would expect from a tree Structural damage Dead branches in-between</p>	<p>12-May-2024 (1 year) general inspection</p> <p>Eventually felling the tree within two years and planting a new street tree instead</p> <p>Pruning of east side branches that touch utility line <u>within 3 months</u></p>

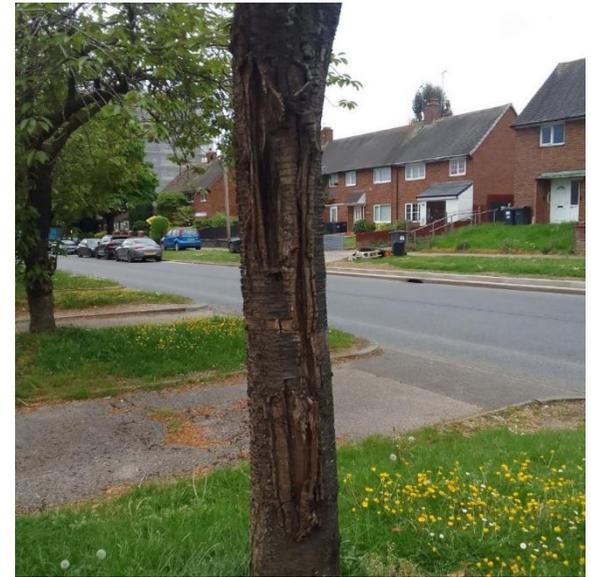
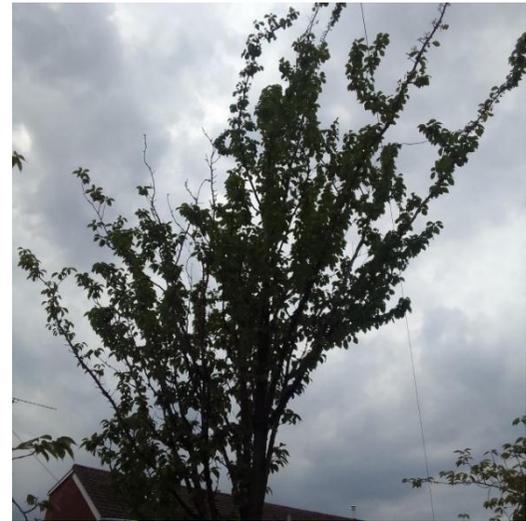
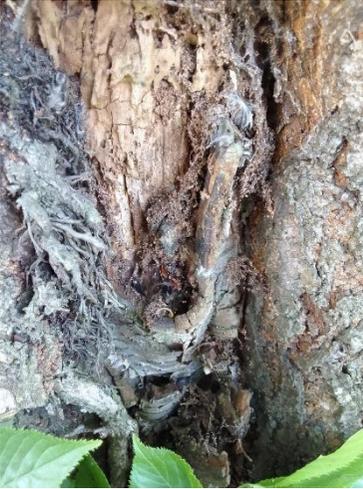
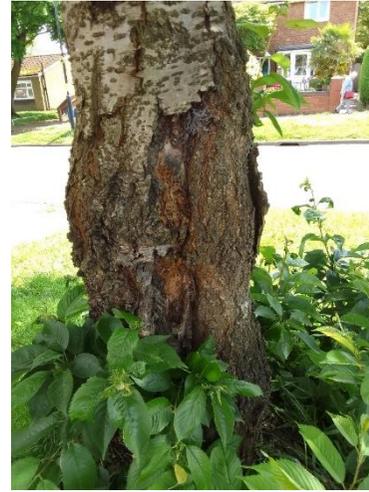
Ref	Species	Description	Measurements	Survey Notes	Risk Rating	Condition	Inspect Period
T04	Japanese cherry (<i>Prunus serrulata</i>)	Owned by Birmingham City Council (BCC) Target # - footpath. - Within drip line. - Occupancy – Frequent (3). - Not practical to move the target.	Height (m): 5 Crown Radius (m): 6-7 North: 2.30 East: 2.10 West: 3.80 South: 2.50 DBH (cm): 95 Life Stage: Mature Life Exp.: 15-20 +Years This one max. 3 years, I assume	Wind Exposure: ¾, house on north side Crown Size: Unbalanced crown. root bulb around 20 cm in diameter Bark cracks: fungi? The trunk has bulbs around Pruning history East dieback 1-10% Around root trunk: new sprouts occur	Moderate	Poor	Every Year

T04	Japanese cherry (<i>Prunus serrulata</i>)	<p>It would be advisable to target pruning some branches to relieve the stress of the tree. Being a street tree perhaps some extra nutrients could hold the decay stage.</p> <p>Improving soil. Make a tree sponsorship through the neighbours who are living in front of the tree.</p> <p>Watering, but observing and eventually collecting data about the decay would be so helpful. Inform the tree warden when the tree deteriorates. Data collection on the spot.</p> <p>A professional tree inspection</p>	<p>12-May-2024</p> <p>Within 2 months</p> <p>The tree is in a line of trees and all of them have fungi and decay issues.</p>

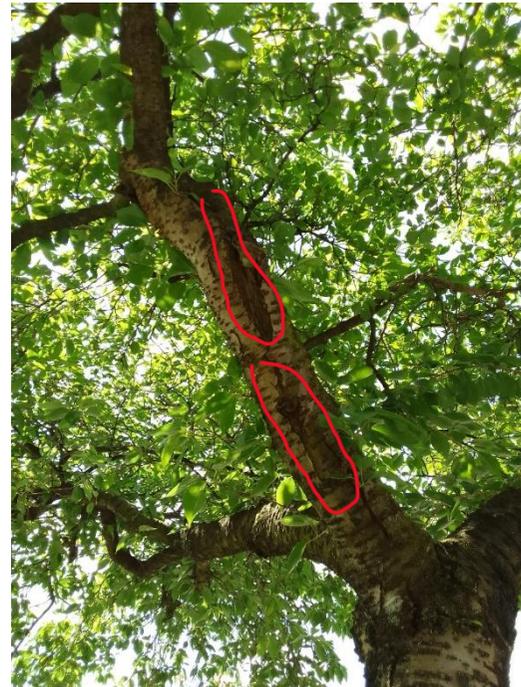
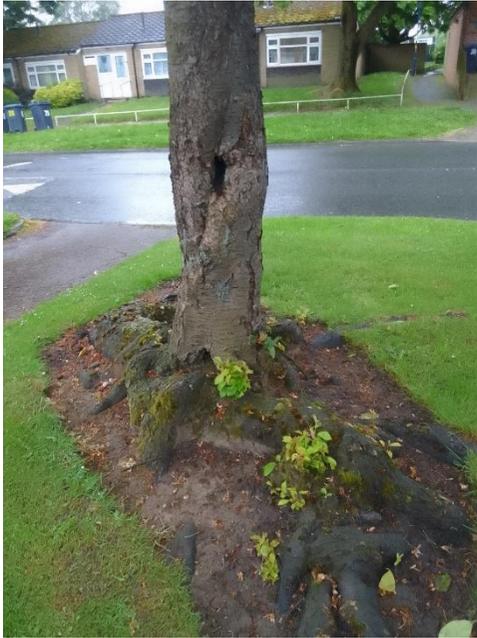
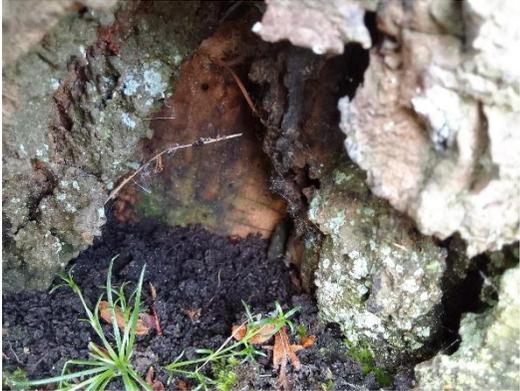
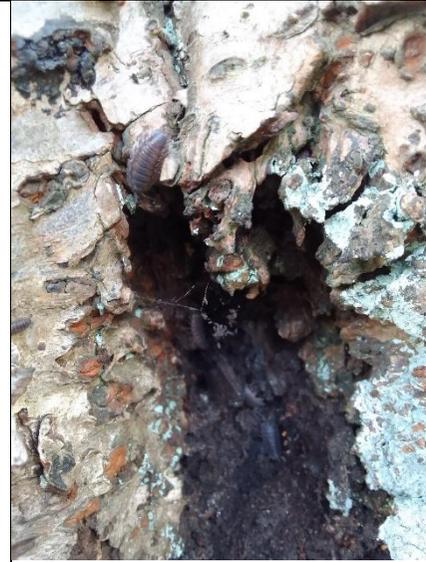
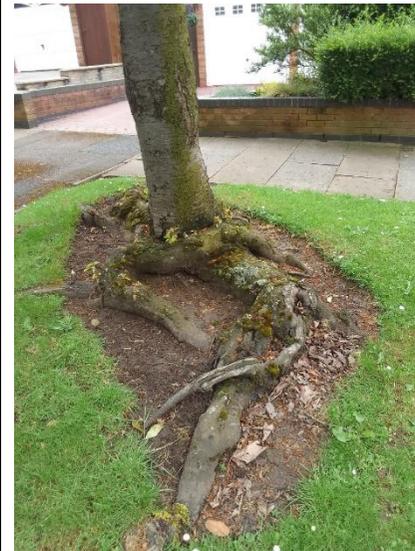
Ref	Species	Description	Measurements	Survey Notes	Risk Rating	Condition	Inspect Period
T05	Wild Cherry Prunus avium	Owned by BCC Target # - footpath; pedestrian way -within the drip line - Occupancy: Frequent (3) - Not practical to move the target.	Height (m): 4.50 Crown Radius (m): 7-8 North: 2.50 East: 2.60 West: 4.30 South: 4.0 DBH (cm): 100 Life Stage: Mature Life Exp.: 60 Years This one perhaps 3 years	Wind Exposure: yes, from $\frac{3}{4}$ house is the north side Crown Size: Unbalanced crown. Dieback: east side 1-10% Fungi black, main trunk crack 5 cm deep Fungi type: was black and in the shape of a bracket before someone destroyed it and I could take a photo. Lichen-type light blue Bark cracks everywhere, partwise deep The trunk has structural damage Roots above ground and tangled	Moderate	Poor	6 months

<p>T05</p>	<p>Wild Cherry (Prunus avium)</p>	<p>This tree is diseased. The fungi decay is everywhere, in the trunk, and roots as far as I could see and reach without a ladder.</p> <p>The recommendation would be to remove the tree (no birds nesting), remove the soil, fill up new soil establish a new planting base in this green area and plant another species; more robust. On the other hand, speak with the neighbour and try to establish a tree sponsorship with a new tree and educate them about taking care of this tree. Often these car owners wash their cars and because of the slope, the soap/chemicals run off the direction tree. Establish a cheap sustainable fence system around the entire green verge for the tree and involve a tree warden and the neighbour if interested in looking after this tree. BTP could do pruning sessions for tree sponsorships...</p>	<p>12-May-2024 Within two years planting a new street tree</p>

Girdling roots are defined as roots that encircle the trunk of a tree, thereby restricting the flow of water and nutrients, and can ultimately lead to the demise of the tree. They are frequently located at or just below the soil surface. A weakened tree may become unstable, thereby increasing the likelihood of it falling during storms or high winds, which could potentially harm targets located beneath it. If the roots are positioned near the surface or are growing in a circular configuration around the tree base, they may negatively impact stability and overall health. A tree exhibiting visible cracks, splits, or cavities in its trunk may be structurally compromised, leading to a state of weakness and an elevated risk of collapse. If the trunk is compromised, the tree may fall unexpectedly, thereby posing a danger to targets located in the nearby vicinity.

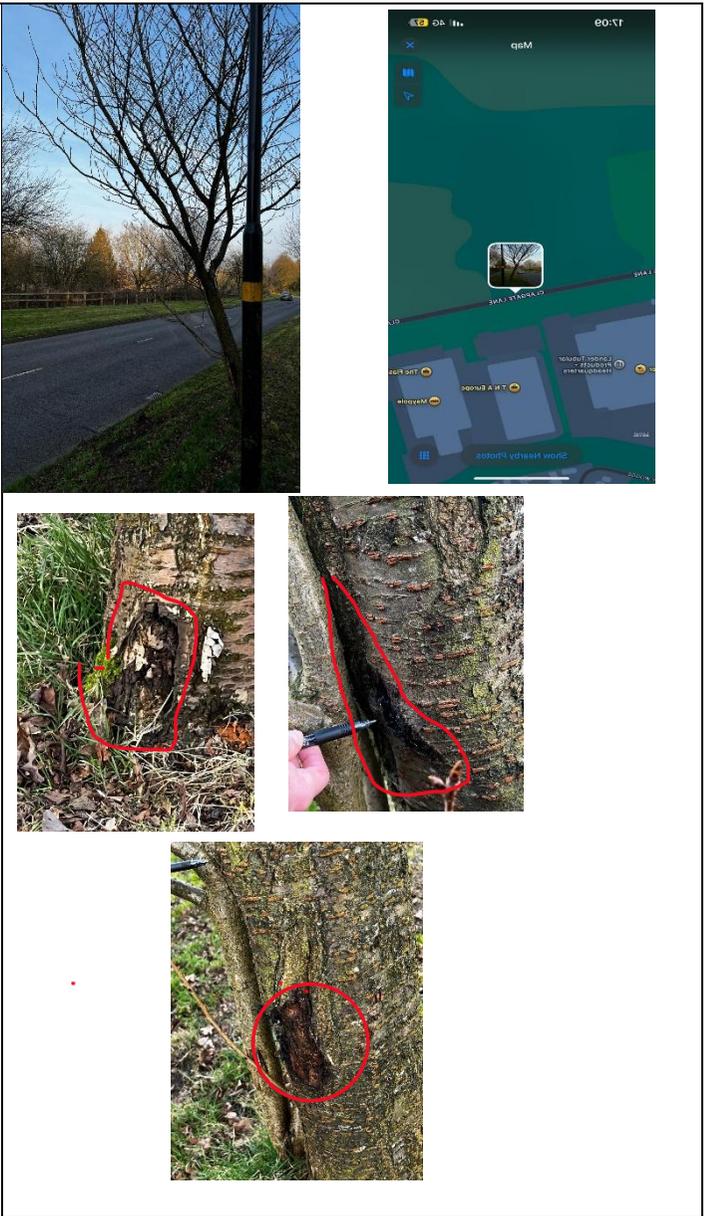
Ref	Species	Description	Measurements	Survey Notes	Risk Rating	Condition	Inspect Period
T06	Pin Cherry Tree Prunus pensylvanica	<p>Location: Clapgate Lane. On grass Verge; one side high traffic street; other side food path Owned by Parks Tree Service Birmingham City Council Target - on a high-traffic street connecting two wards - Outside drip line. - Occupancy - Frequent (3). - Practical to move the target.</p>	<p>Height (m): 4 Crown Radius (m): 2.7 DBH (cm): 22 Life Stage: Young Life Exp.: 5 Years</p>	<p>Wind Exposure: Full. Crown Size: 2 meters Unbalanced crown. Leaning trunk towards the street 1 trunk Fungi on trunk Bark damage on the trunk base</p>	High	Fair	yearly

<p>T06</p>	<p>Pin Cherry Tree <i>Prunus pensylvanica</i></p>	<p>Removing the tree Leaning trunk towards the street can endanger public traffic One trunk Black Fungi on the trunk Bark damage on the trunk base</p>	<p>Removal of the tree asap Planting a new street tree within 1 year March 2026</p>

Tree 06 is leaning at a 40-degree angle towards a busy road, creating a danger for drivers. A tree is considered unsafe if it leans 15 degrees or more or if its lean increases over time. This is more critical if the tree has diseased or dead parts. Tree 06 has a black fungus and damage at its base. It should be removed to prevent accidents and injuries, especially with high winds and storms expected. Removing the tree will help ensure safety on the road.

Tree 06 is a tree leaning towards a high-traffic road at a 40-degree angle which poses a risk to motorists. If a tree leans 15 degrees or more, or if you see that the angle of lean is growing over time, it is deemed unsafe. This is particularly true if the tree has any diseased or dead sections. At this point, the tree should be removed from the property to mitigate potential safety hazards. The tree suffers already from a black fungus and damage around the trunk base. It would be proactive to remove this tree as the straight street has high winds, especially with increasing storms coming up. This will eliminate the risk of injuries if the tree falls on the road. Opposite the road is a plain wide field with strong winds pushing towards the street and trees. It would be beneficial to plant hedges on the green verge area to puffer windthrown.

For **Tree 06**, it has been recommended that removal take place. This measure eradicates all associated risks; however, it complicates the achievement of the City Council's canopy percentage goals. Should the planting plot not be replanted in a timely manner, the residents may grow accustomed to utilizing this space for the disposal of litter from their vehicles. Additionally, the planting of hedges adjacent to the green verge areas of this heavily trafficked road could also mitigate noise and pollution in this locality.

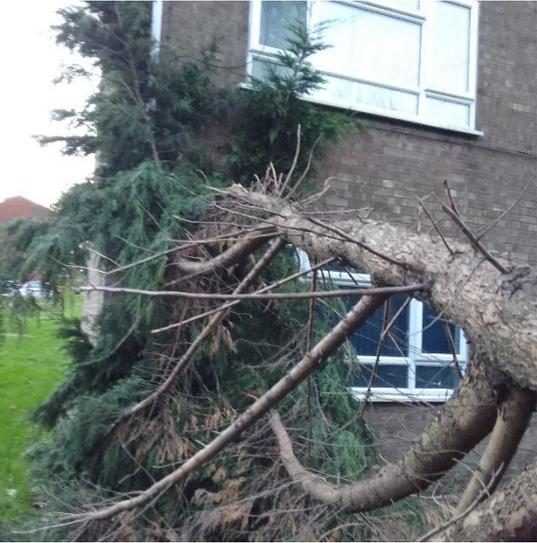
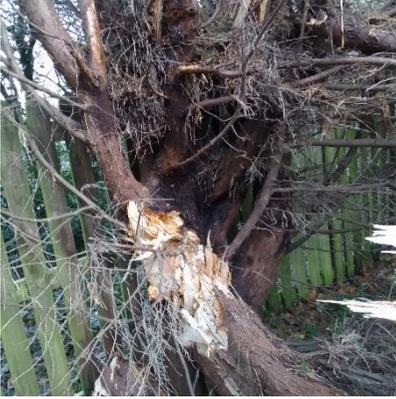
Ref	Species	Description	Measurements	Survey Notes	Risk Rating	Condition	Inspect Period
T08	Leyland Cypress (Cupressus x leylandii)	Location: Clent Way Estate Owned by GSA HA Target pathway - Within the drip line - Occupancy - Frequent (3) Pruning of the entire tree could minimise the risk of falling onto the building short-term Long-term removal of the tree and planting of new conifer	Height (m): 15 Crown Radius (m): 8 DBH (cm): 80 Life Stage: Mature Life Exp.: 40+ Years	Wind Exposure: Full. Crown Size: Large. Unbalanced crown. Multiple Stems Trunk rotten Black fungi decay Storm damage from 8 th December 2024 Pruning of branches short-term Removal of the tree long-term and planting a new tree	High	Poor	Needs to be inspected and pruned asap within 3 working days

<p>T08</p>	<p>Leyland Cypress (Cupressus x leylandii)</p>	<p>Multiple Stems Trunk rotten Black fungi decay Storm damage from 8th December 2024 Pruning of branches short-term Removal of the tree long-term and planting a new tree</p>	<p>Pruning tree branches <u>asap within three working days</u>; short-term Long-term: removal of the entire tree and planting of a tree</p>

Tree 08 exhibited numerous issues that rendered it weak and more susceptible to breaking during the storm on December 8, 2024. It possessed multiple stems, which introduced weak points, thereby facilitating the breakage of branches under stress. The trunk suffered from rot and decay, exacerbating its vulnerability during adverse weather conditions, which could result in sections of the tree falling onto nearby objects. The presence of black fungi decays further compromised its structural integrity, increasing the likelihood of failure. Moreover, the tree contained dead and weak branches that could easily break in strong winds, thereby posing a risk to nearby structures or individuals. Should the tree have been leaning to one side, it might have heightened the risk of breakage during the storm. Overcrowded branches and dense foliage might obstruct airflow and create greater wind resistance, consequently further weakening the tree. Furthermore, had Tree 08 possessed damaged or shallow roots, it would have been less stable in the face of heavy winds or storms. Trees positioned close to buildings or pathways are capable of inflicting significant damage if they were to fall. Finally, if the tree had a history of suffering damage from previous storms, it would likely have been more prone to breaking again during this particular storm.

For **Tree 08**, which has previously experienced storm damage, careful monitoring should be conducted following each subsequent storm. Consistent maintenance and evaluations after significant storms will assist in identifying any new vulnerabilities before they result in failures. Should the tree be considered beyond safe repair or if mitigation strategies prove ineffective, it may become necessary to contemplate the complete removal of the tree and its replacement with a more appropriate, structurally sound species.

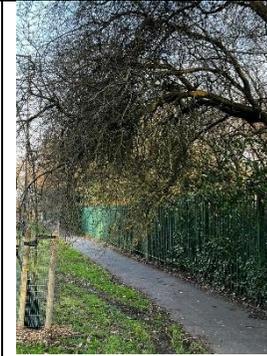
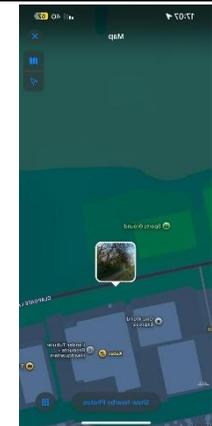
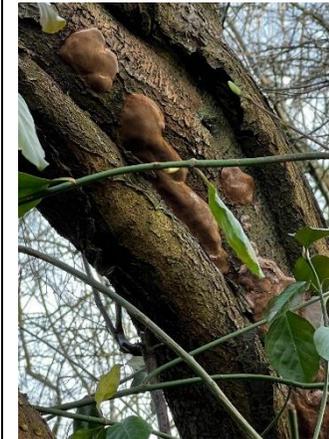
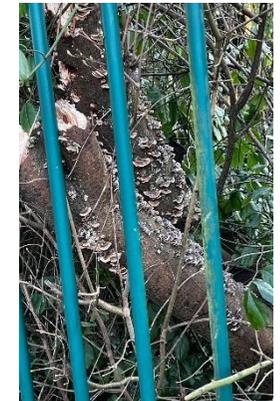
Ref	Species	Description	Measurements	Survey Notes	Risk Rating	Condition	Inspect Period
T09	Ash tree Fraxinus excelsior	<p>Location: Clapgate Lane Ownership: The land, including the area where the business park is situated, was owned by Birmingham Corporation by 1953 and is now managed by Birmingham City Council.</p> <p>Target: footpath - Within the drip line. - Occupancy - Frequent (3). - Practical to move the target.</p>	<p>Height (m): 16 Crown Radius (m): 3 DBH (cm): 40 Life Stage: Mature Life Exp.: 40+ Years</p>	<p>Wind Exposure: Full Crown Size: Large Unbalanced crown Leaning trunk towards the street Diseased in the trunk area with fungi</p> <p>cushion bracket fungi on a branch; Phellinus poaceus</p> <p>other branch fungi: Polypore, also known as bracket or shelf fungi. More specifically, it strongly resembles Crimped Gill fungus (<i>Plicatura crispa</i>)</p> <p>Interferes with a newly planted street tree</p>	High	Poor	Asap Needs branch removal towards the street

<p>T09</p>	<p>Ash tree Fraxinus excelsior</p>	<p>Leaning trunk towards the street and spanning completely the footway. Diseased in the trunk area with fungi cushion bracket fungi on a branch; Phellinus poaceus other branch fungi: Polypore, also known as bracket or shelf</p>	<p>Target pruning of affected branches within 4 weeks.</p>

fungi. More specifically, it strongly resembles Crimped Gill fungus (*Plicatura crispa*)

Interferes with a newly planted street tree

The identification of *Phellinus pomaceus* (cushion fungus) and Polypore (shelf fungus) on the branches and trunk signifies potential decay or disease affecting the tree. The growth of these fungi can compromise the tree's structural integrity, increasing its vulnerability to breakage or collapse. Fungal infections and diseases frequently lead to the deterioration of the wood within the tree, resulting in a loss of structural stability. A compromised trunk or branch is at a higher risk of snapping, particularly during storms or strong winds, which poses a danger to individuals situated beneath it.

Tree 09 covers the walkway and is bowed, leaning towards the street. Both *Phellinus pomaceus* (cushion fungus) and Polypore, sometimes referred to as bracket or shelf fungus, are present on the tree's branches, causing disease in the trunk area. In particular, it has a striking resemblance to the Crimped Gill fungus (*Plicatura crispa*). A recently planted street tree will be hampered by the weight of the drooping branches, as well as by having less room to grow and less sunlight. Pruning serves to alleviate the burden of drooping branches, which can diminish stress on the trunk and the overall structure of the tree, thereby mitigating the risk of further leaning or potential breakage. By eliminating overgrown or unhealthy branches, the tree can gain improved access to sunlight, a crucial element for its photosynthesis. This enhancement may bolster the tree's overall health, particularly if it is being overshadowed by nearby structures or other trees. Pruning can facilitate better air circulation within the canopy, thereby decreasing the risk of fungal infections such as *Phellinus poaceus* or Polypore, which thrive in damp and stagnant environments. By excising diseased or damaged branches affected by fungal infections, the tree can redirect its energy towards healthier, unaffected areas, potentially hindering the spread of the disease. Pruning a tree already under stress from disease may exacerbate its condition. Excessive pruning or performing it at an inappropriate time of year can increase the tree's susceptibility to diseases or environmental pressures. Improper pruning techniques can create wounds on the tree, which may become entry points for additional fungal infections. The presence of *Phellinus poaceus* and Polypore could continue to impact the tree even post-pruning, potentially worsening the situation. Given that the tree is already burdened by the weight of its branches and suboptimal growth conditions, pruning may hinder its overall growth and the development of a stable structure. If too much of the canopy is removed, the tree may find it challenging to regenerate new growth.

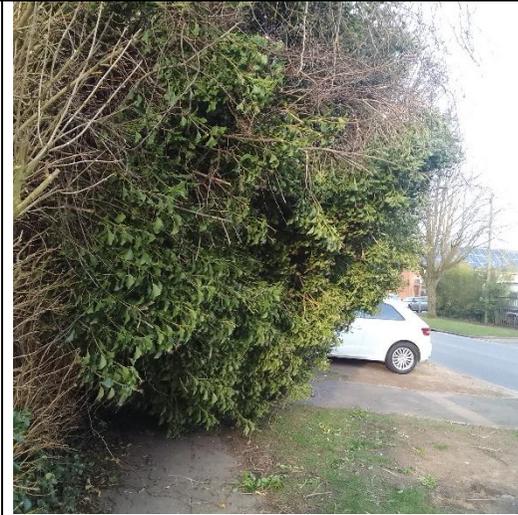
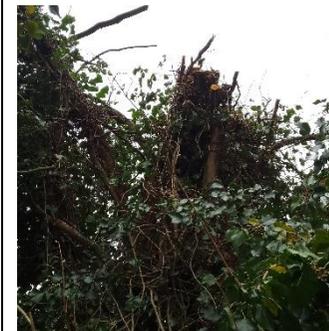
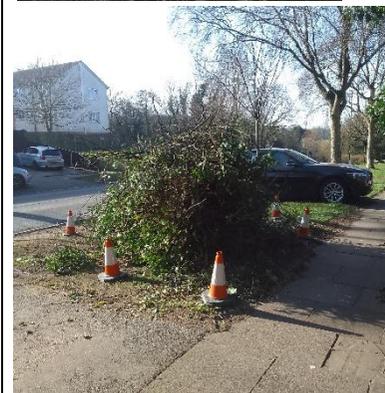
Ref	Species	Description	Measurements	Survey Notes	Risk Rating	Condition	Inspect Period
T10	Cockspur hawthorn (Crataegus crus-galli)	Location: Kitwell Lane 127 Owned by GSA HA Target footpath to flats and pathway street - Within drip line. - Occupancy - Frequent (3). - Practical to move the target.	Height (m): 5 Crown Radius (m): 2 DBH (cm): 24 Life Stage: Mature Life Exp.: 40+ Years	Wind Exposure: Half Crown Size: 2 Unbalanced crown. Leaning trunk towards the street pathway The tree is overgrown with common ivy which caused the tree to split under the weight of the ivy.	High	Poor	Asap Pruning and removing ivy

Leaning trunk towards the street pathway
The tree is overgrown with common ivy which caused

the tree to split under the weight of the ivy.

The tree has weak and split branches because of heavy overgrown ivy, which harms its structure and leads to falling branches that could injure people or damage property. The ivy adds weight and makes it hard to check for dangers while also blocking the view. If the tree bends toward the pathway, the low-hanging branches might have hit pedestrians, or cyclists, causing injuries or damage.

Pruning asap and removing the common ivy within 3 working days

For **Tree 10** identify possible targets (e.g., pedestrians, vehicles, buildings) in the vicinity of the tree and prioritize protective measures for these targets. Remove the ivy to decrease its weight and to avert further damage to the tree. It is imperative to remove the ivy at the base, where it links to the trunk, to diminish the risk of stress on the tree. After the removal of the ivy, monitor the tree to prevent regrowth and reestablishment of the ivy. Regularly inspect and manage any new growth to prevent a recurrence of the issue.
